凝汽器钛管断裂失效分析

摘 要:核电作为一种高效、清洁可循环利用的能源显得尤为重要. 核电机组的安全运行备受关注. 针对国内某核电机组凝汽器运行中钛管断裂现象进行了失效分析,通过光学显微镜,三维体式显微镜,扫描电镜,对钛管失效部位的化学成分与显微组织及断裂处的微观形貌进行了表征,并结合类似设备失效分析的经验,提出了造成材料失效的因素是管内壁的疲劳腐蚀,对苛刻工况下的凝汽器管道维护和保养提供了参考:(1)加强管材的加工质量控制,消除原始材料缺陷,在运行过程中,重点做好顶部管束的质量监控;(2)凝汽器运行前排空水室顶部的空气,减少启动阶段蒸汽的冲击振动;(3)加强凝汽器的稳定运行控制,减少变工况运行.

Failure analysis on titanium tubes in condenser

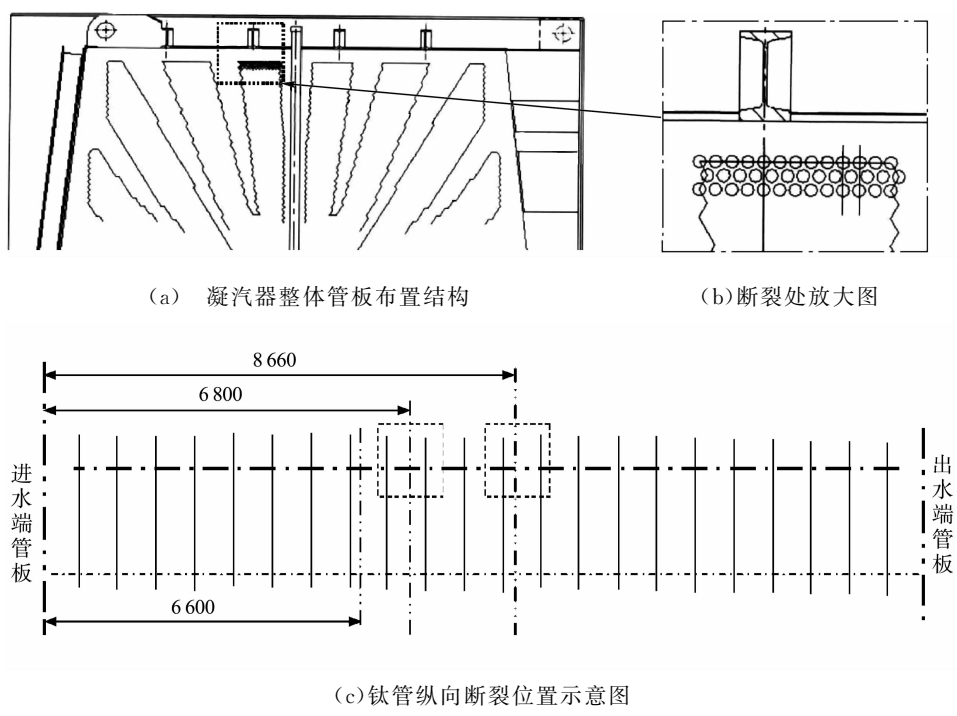
图 2 钛管断裂失效位置
Fig. 2 Titanium tube fracture defects position

图 2 为失效钛管的分布位置示意图,检修过程中发现断裂失效的钛管处于顶端位置(见图 2)在水流方向距离进水端管板 6 800 mm 和 8 660 mm 处发现两处断裂,同时发现裂纹附近管内壁有积垢存在.使用渗透剂检查,发现裂纹呈圆周方向分布,如图 3 所示.

两处断裂失效钛管的位置均在凝汽器管束的最上层,开裂位置位于钛管长度方向两管板的中间位置(如图 2 所示),该位置为蒸汽冲击振动最为严重的地方.在机组的调试、运行工况下,尤其是调试阶段,机组的启停、变工况运行均会对凝汽器冷却管造成严重的冲击作用,导致材料的破坏.

(1)加强管材的加工质量控制,消除原始材料缺陷,在运行过程中,重点做好顶部管束的质量监控;(2)凝汽器运行前排空水室顶部的空气,减少启动阶段蒸汽的冲击振动;(3)加强凝汽器的稳定

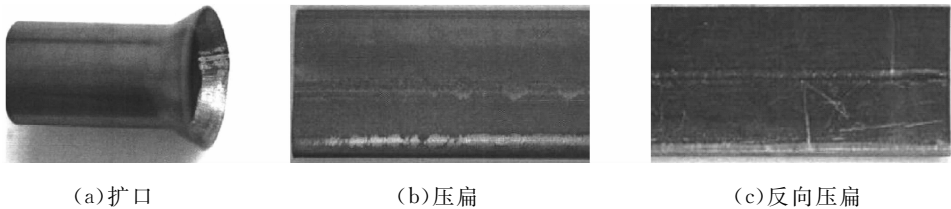
图 4 钛管力学性能检查

按照 ASME SA370《钢制品力学性能试验方法及定义》对失效钛管进行拉伸试验及扩口、压扁和反压扁测试,试验结果如表 2 和图 4 所示.试验结果表明,在役钛管的力学性能符合国家标准 GB/T 3620.1-2007 和 ASTM B338 标准的要求.

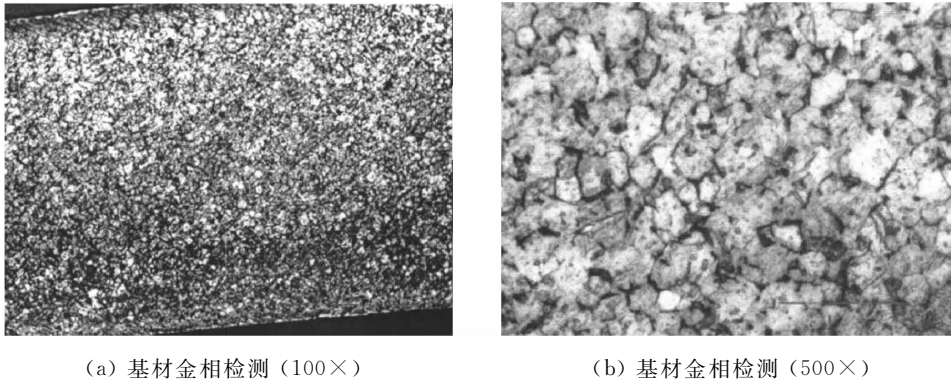
图 5 钛管金相组织检查

对在役钛管进行了金相组织检验,如图 5 所示,结果显示材料为典型 α 相钛显微组织,晶粒分布及大小均匀,未见晶间缺陷,符合钛金属材料的金相组织特征。

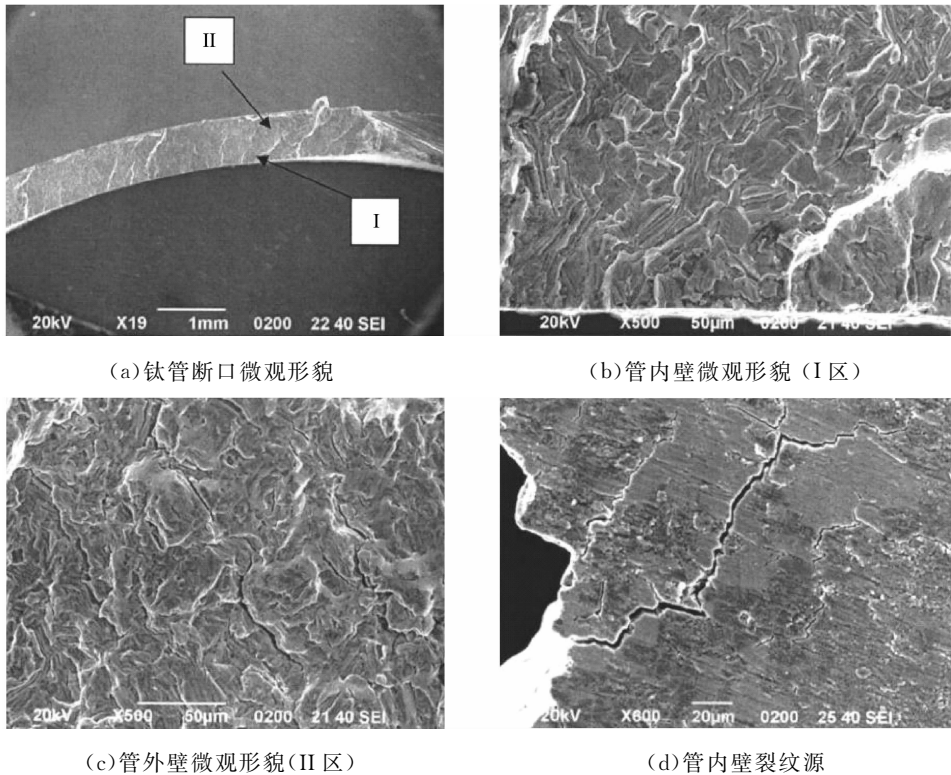
图 6 钛管裂纹断口 SEM 照片

采用扫描电子显微镜(SEM)对断裂处的显微形貌进行观察和分析,如图 6 所示,可以看到断口

的裂纹源于钛管的内壁,逐渐向外扩展.图 6(b)中显示管内壁存在裂纹,而在图 6(c)中所示的外表面完整.图 6(d)更清晰地表征了内表面的微裂纹,证明裂纹萌生于钛管的内壁。

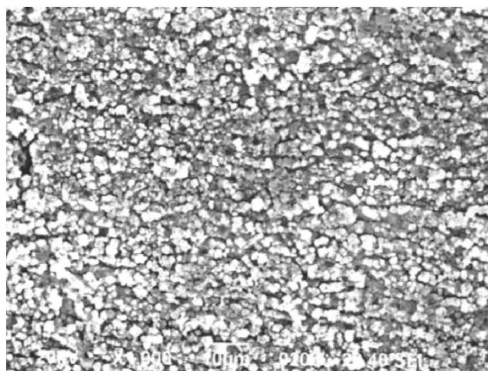
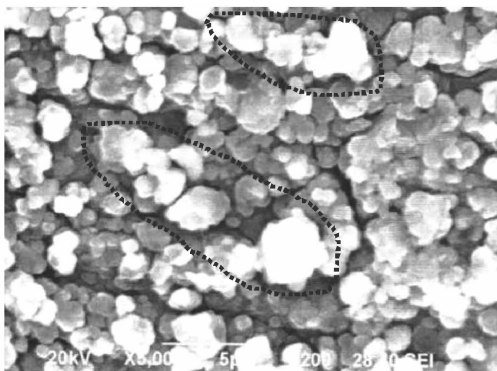
图 7 钛管裂纹源晶体 SEM 照片

为了进一步分析钛管材料微裂纹产生的原因,对管内壁裂纹源处采样进行微观分析,如图 7

凝汽器顶部蒸汽温度最高,进入顶部钛管内部的海水在一定的条件下可能汽化形成液气两相,管内壁局部海水会蒸发析出异质盐分结晶.虽然钛金属的耐腐蚀能力较高,在钛管的局部表面仍然会发生海盐的侵蚀现象.

在凝汽器长期的运行过程中,一方面管束顶部的钛管受变工况蒸汽冲击产生振动,在管板中间处的管束容易产生材料的疲劳失效;另一方面在管内局部高温位置,钛管内壁存在材料的侵蚀.在冲击振动和材料表面侵蚀的双重作用下,钛管局部形成材料的疲劳腐蚀,最终导致断裂失效.

中虚线所示,发现裂纹附近内表面存在疑似矿物盐等异质结晶现象.
